Identification of the Zrínyi Ditch – An Engineer Obstacle Built in 1662¹

József Padányi – Lajos Négyesi – László Nagy

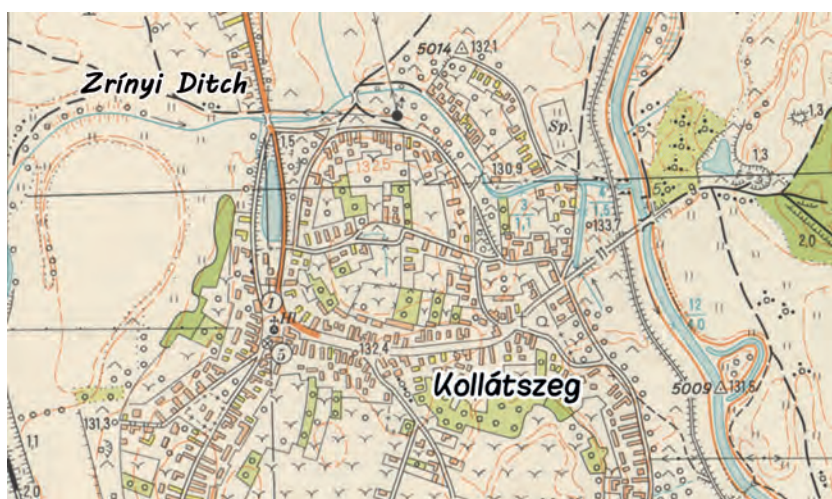
Figure 2.

Map sheet showing the flow direction of water in the ditch

The quotation from Vitnyédy clearly shows that the ditch led the water of the Mura into the Kanizsa Stream. The question is how the inclination of the terrain affected the shape and depth of the ditch. Looking at the map, it is difficult to tell the lateral inclination angle of the terrain between the Mura and Kanizsa Stream. Based on cartographic data, there is no significant difference between the water levels of the Mura and Kanizsa Stream, less than three kilometres from their confluence. This is confirmed by the fact that most of the village of Kollátszeg is found within a 131.25-metre high contour line, so the terrain has no dominant slope in any direction. On a map sheet from the 1970s, however, the water in the ditch is clearly shown flowing towards the Kanizsa Stream (*Figure 2*).

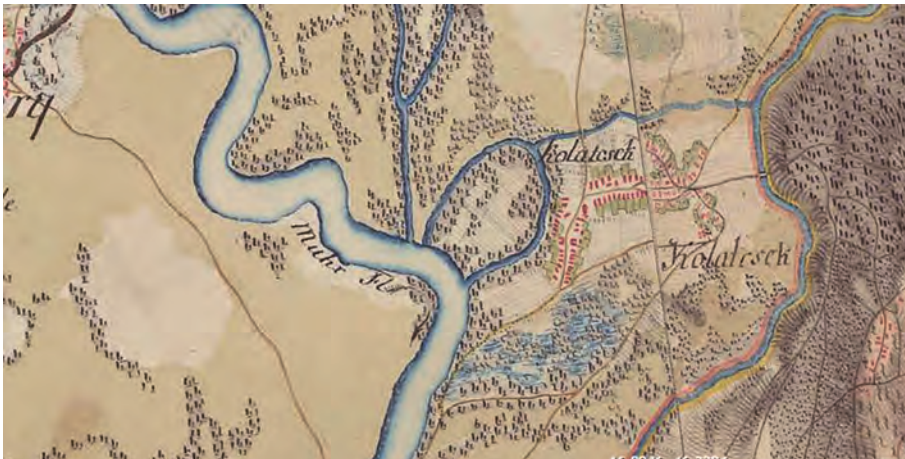
Figure 5.

The results of the First Military Survey

The First Military Survey also shows the examined section of the Mura and distinctly depicts its oxbow and the ditch linked to it (*Figure 5*). The other end of the ditch is clearly connected to the Kanizsa Stream. It is worth noting here that there is no other ditch between Murakeresztúr and Kakonya connecting the two rivers. There is one more important point of orientation on the road from Murakeresztúr, namely the bridge above the ditch in the vicinity of Kollátszeg.

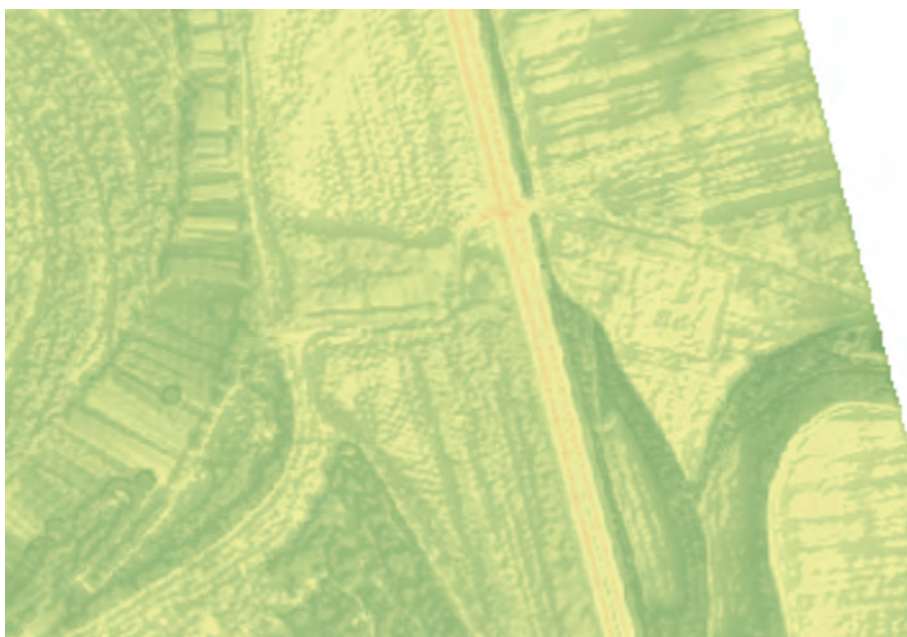
Figure 10.

Details of the Zrínyi Ditch identified on the LIDAR image

As the description of investigations in the field demonstrates, the analysis of micro-morphology plays an important role in identifying the line of the ditch. The largest scale map (1:10,000) available to us shows a 0.5-metre difference of level. We need a higher definition than that. That is why, at the beginning of the research, we decided to carry out a LIDAR (Light Detection and Ranging) surveying of the area, if we had the financial resources for that. The application of this method considerably helped our work during our investigation of Zrínyi-Újvár.³⁷ As a matter of fact, every field research where micro-morphological features may be significant should begin with LIDAR surveying. However, the sum of money that is required for this is rarely available at the start of the work. We received help in this from the West-Transdanubian Water Management Directorate that had previously surveyed the area with this method and provided us with their data set.³⁸ The assessed images clearly show the interventions made in the field. Based on this, we received further confirmation, which is demonstrated in *Figure 10*.
