The Excavation of the Well in the Fortress

László Vándor

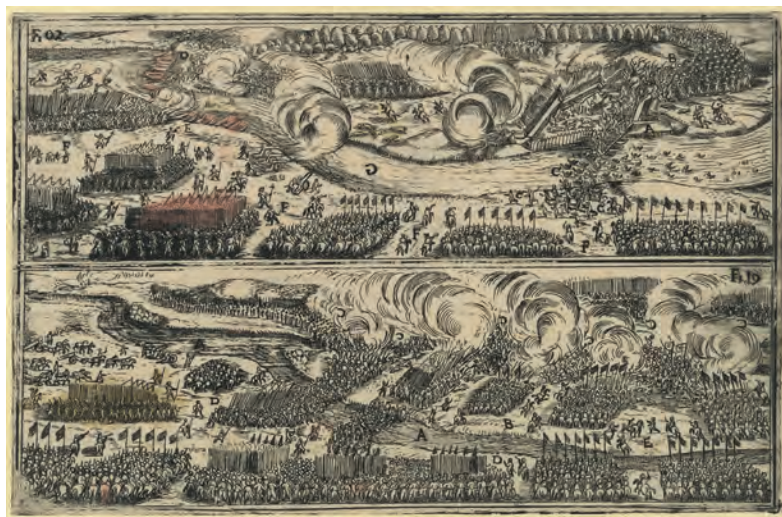
Figure 3.

Map by Pál Esterházy depicting the well in the middle of the fortress

The third most important source of the existence of the well is the site plan attached to Pál Esterházy’s *Mars Hungaricus*, which depicts a feature identifiable with the well approximately at the site of our excavation.¹⁴

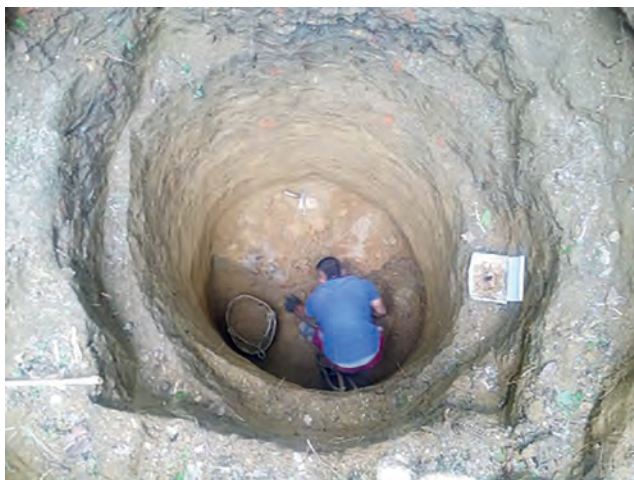
Figure 4.

The first phase of digging deeper in the well

We began the excavation of the well in a usual round shape after clearing the area and removing the collapsed wall. Below a depth of three metres, modern materials disappeared from the backfill of the well. The small number of finds coming to light was dated to

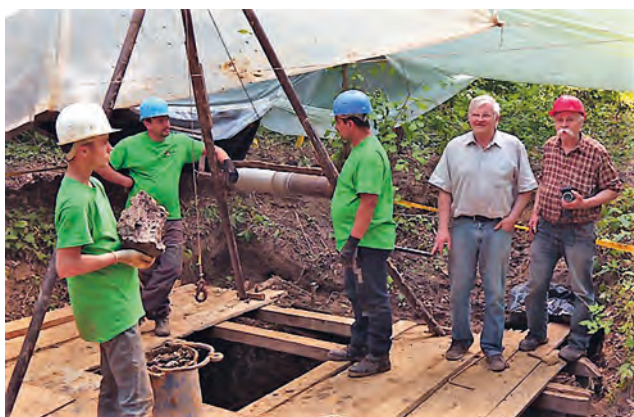
Figure 5.

The well during excavation and the tools of the excavation

After reaching a depth of about four metres, we continued the excavation with the construction of a post structure around the area and making a three-legged iron ladder to allow the well-digger descend and ascend with the soil.

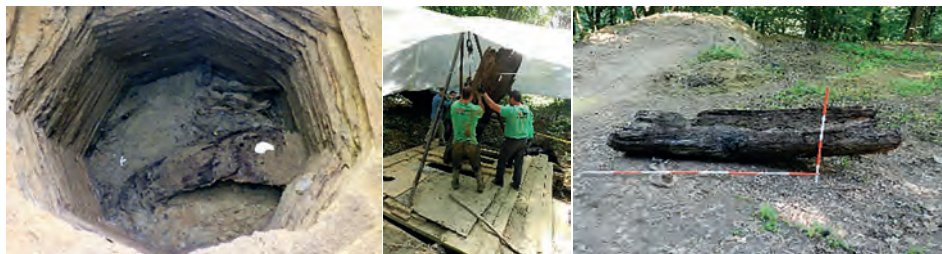
Figure 8.

The drinking trough in the well, during lifting and after cleaning

The largest wooden object was a drinking trough that once stood next to the well. Based on its position, it was the last object to have been thrown into the well. The softwood trough hollowed out of a single tree trunk came to light almost intact.

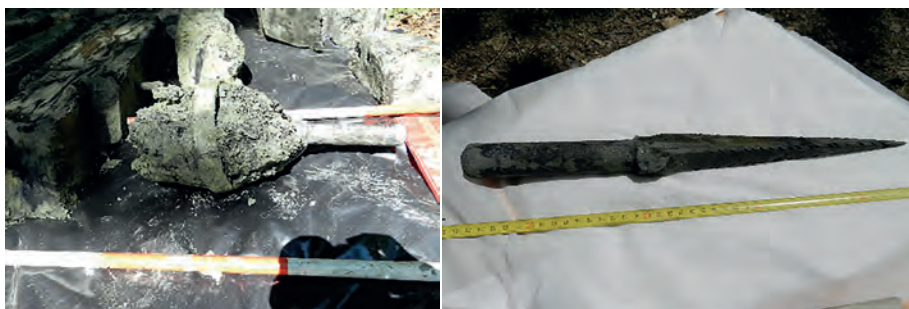
Figure 9.

The end of the wheel cylinder with an iron band and iron pin nail, as well as the iron pin nail

The well curb could be reconstructed from a few pieces. The structure above the surface was built of elements identical to the lining, which was closed with pieces of wide, horizontal planks. Water was fetched with the help of a cylindrical structure used at wheel wells. The drum was held by upright beams that were drilled through, and both of its ends were reinforced with iron bands, fastened with iron pin nails. Unfortunately, the structure (either a wheel or a rod handle) used for moving the cylinder has not been found.

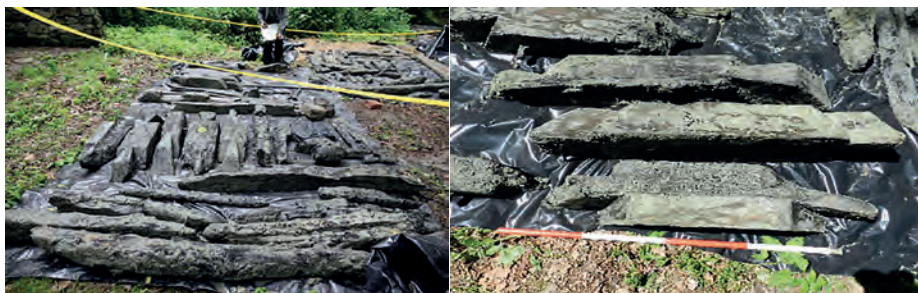
Figure 10.

Timber items uncovered from the well and parts of the well lining

The lining of the octagonal well was made of oak planks with sawn ends for easy joining. The elements of the lining were designed to be easily fitted into one another and the imprecisions of the pre-made pieces at the joints would not cause any problems. Due to this method, the lining could be excavated very quickly.

Outstanding items from clearly identifiable finds include the burnt fragments of the well drum discussed above, a fragment of one of the beams supporting it, pieces of the well curb and the well lining, timber shingles belonging to the dome (including intact pieces), as well as some sawn, intact or fragmented decorative elements.

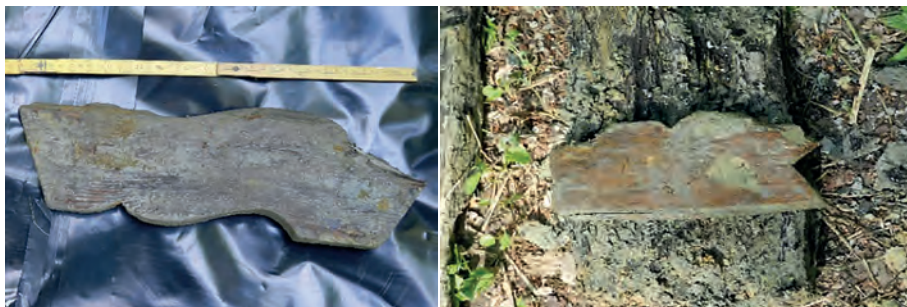
Figure 11.

Shaped pine board pieces from the structure erected above the well

The structure erected above the well could not be fully reconstructed from the discovered elements. Based on contemporary records, however, it seems that it was dome-shaped, and it was covered with timber shingles. The data of written sources have been supported by the finds discovered at the site.¹⁶ The dome must have had a round or rectangular base. According to experts in the woodworking industry, the carpentry technique employed is suggestive of a rectangular base. Based on the sawn timber planks, there could have been a beautifully made protective fence above the well.
